SAFETY ALERT

PRECISION HYDRAULIC LIFT WIRING

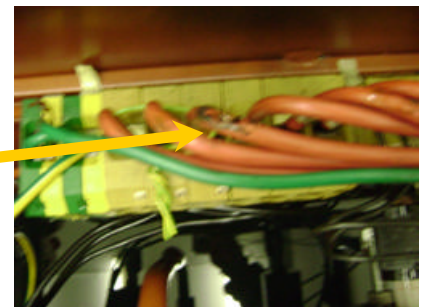
- Service Technician sustained an electric shock.
- Incident investigation identified a design fault in the “Precision Hydraulic Lift” tank in lift motor room.
- Wiring terminal block located in close proximity to lid – when lid is in place part of the lid was sitting on one of the phase wires.
- Over time, the insulation on that wire had worn away.
- As the lid normally sits on foam rubber sealant material, the lid was isolated from the (earthed) tank (the lid was not bonded to the main earthing system).
- With the wire exposed, when the lid was pressed down contact was made between the lid and the tank, with a circuit being formed and a risk of earth leakage

Note the deformed insulation on the 5th wire from the left.
Note the compromised insulation on the 3rd red wire from the left.

The arch of the wires coming out of the terminal block needs to be decreased to prevent contact between the lid and the wires.
