SAFETY ALERT

Australian Elevators
Association Limited

Lifting beam not installed correctly by builder

Dated: February 2019

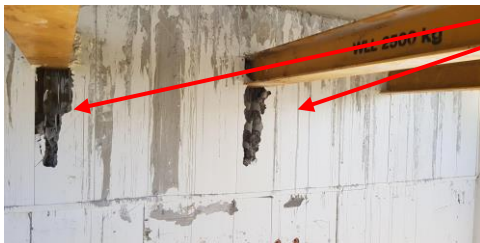
The mechanics' previous experience with this type of formwork system led them to be extra diligent in their checks of the area beneath the beams which revealed no concrete supporting the beam.

Concrete Missing Below Beams

1. Ensure you have certification of the lifting points prior to commencing shaft work
2. When working on a site with permanent polymer formwork, verify the area under lifting beams is solid with no void beneath the surface either by drilling or checking the area is solid.

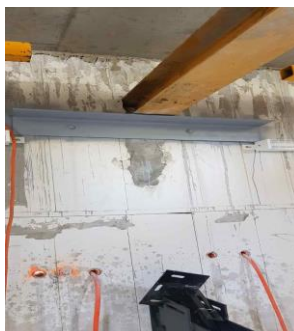
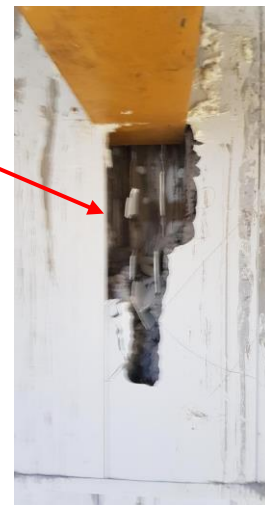
Rectification works

The builder carried out rectification works

1. Filled the void with a specialized concrete grout,
2. Installed a shelf angle with extra-long tru-bolts into the wall
3. Certified the beams were installed correctly to take the 2500kg load.
