## Schindler 9300: Tightening screws of the handrail friction wheels

Handrail friction wheel of Schindler 9300AE escalators.

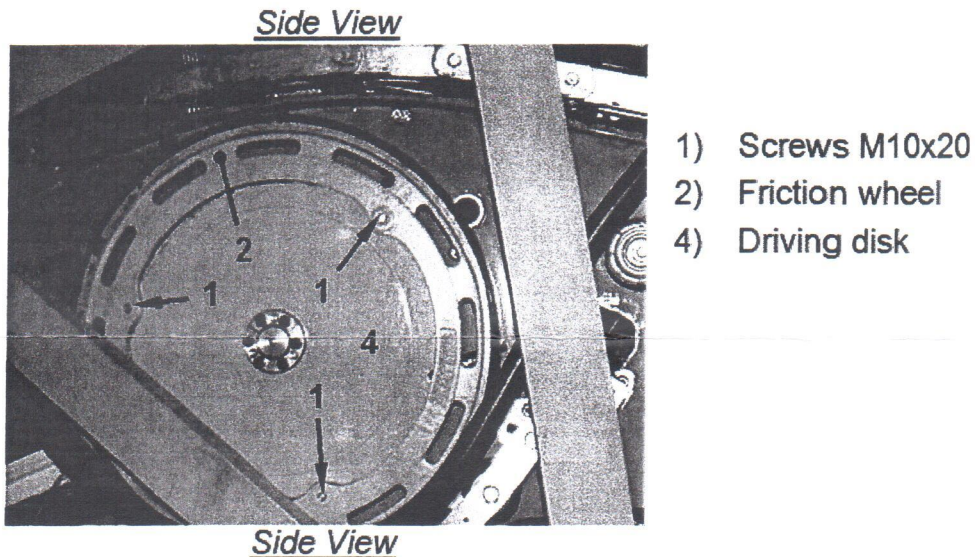
On a small number of units it was found that the screws of the handrail friction wheels were not sufficiently tightened during manufacturing/assembly and therefore may come loose.

This caused the handrail friction wheel to partially come away from its drive mechanism (hub) which caused a deformation in the hand rail pressure roller assembly mounting bracket and the area of the escalator truss where this bracket was attached.

In that case a number of escalator steps impacted on the deformed area of the truss causing local impact damage to the riser of the steps

The damaged steps may lead to a risk of injuries if the damaged steps are not identified and the escalator is put into operation again.

Schindler Lifts Australia offers to carry out a check of your unit to check and retighten all screws on the hand rail friction wheel with a torque wrench to a torque of 55 Nm.

Also your maintenance provider needs to carry out regular maintenance checks
