# National EHS Alert

## Wilco Switches

### Incident Detail

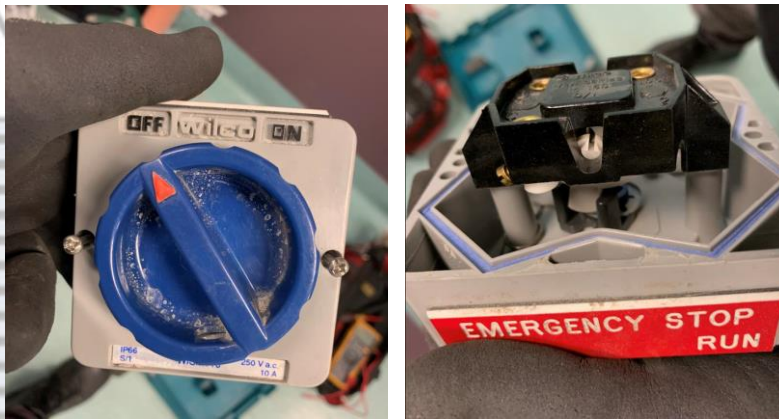
All Wilco and Clipsal switches that are being used as stop switches, like the type pictured (left) below must be replaced. If you find a faulty stop switch it must be immediately replaced.

In 2009 it was identified that situations occur with rotary type of Wilco switches where you can turn the switch to the off position, but it doesn't actually turn off the power. The contacts inside the switch remain closed and don't open.

**The switch is like the one shown below:**

- If you find a faulty Wilco Switch immediately replace it, for your safety and others.
- If you find a Wilco switch that is not faulty please raise a repair request, so that it can be replaced.

- There are known failures with rotary types of Wilco/Clipsal switches and they must be replaced if installed as a safety stop switch.
